Rotorua Te Arawa Lakes Aquatic Plant Management Plan

Prepared for Bay of Plenty Regional Council & Land Information New Zealand

8 May 2020

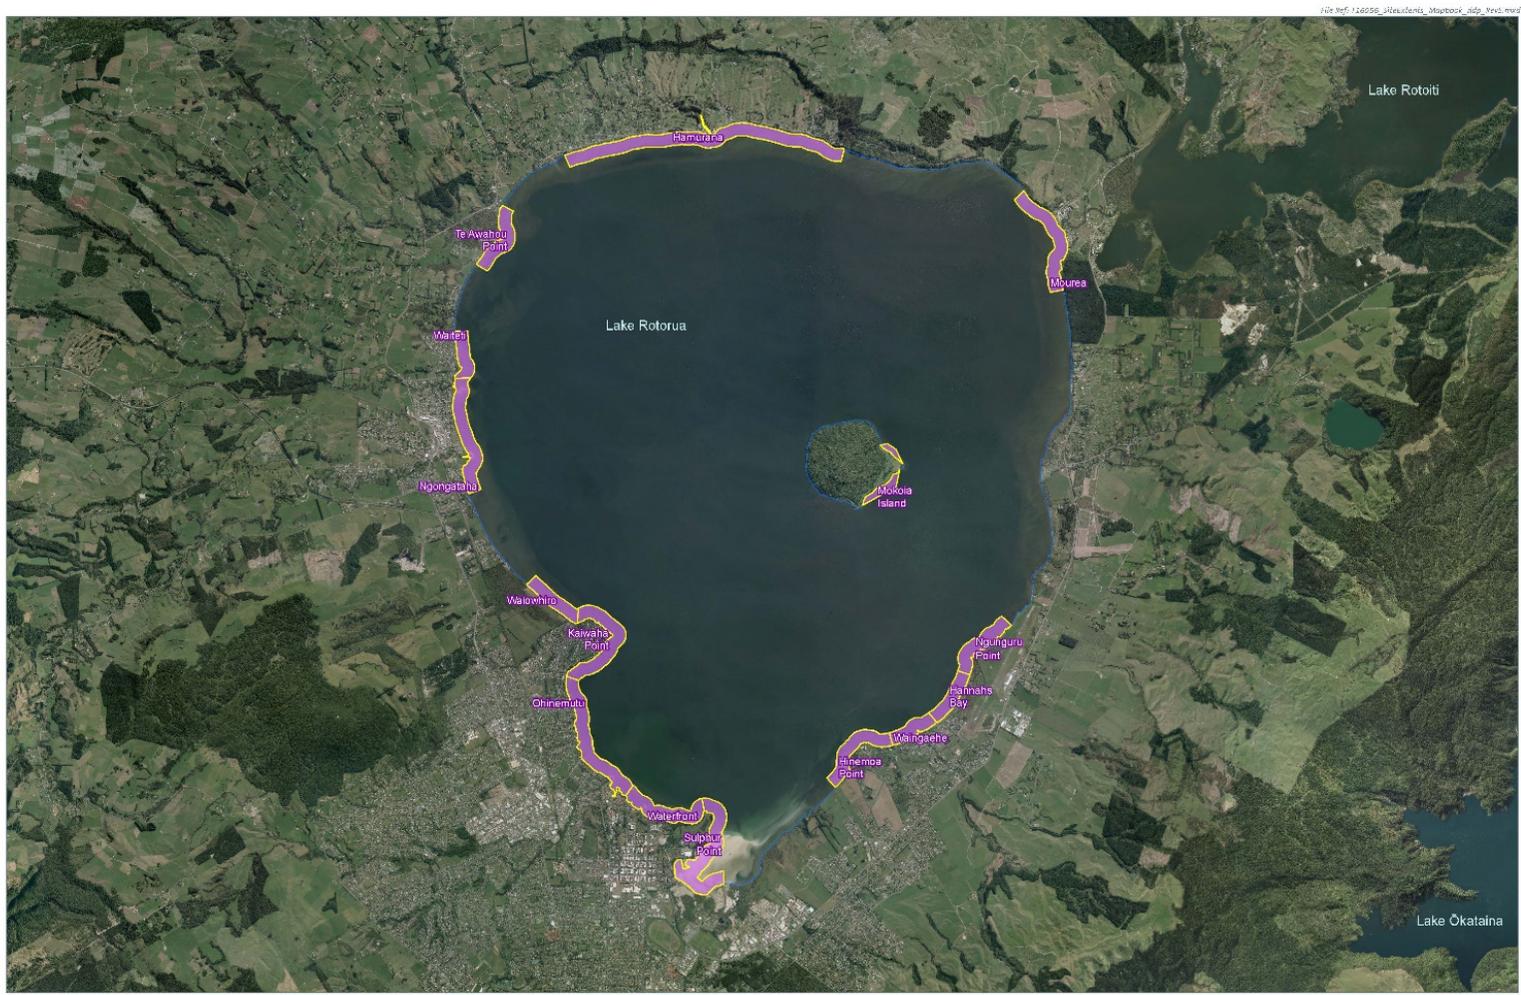
ROTORUA LAKES MANAGEMENT PLAN
Site Extents - Lake Rotorua - Figure 9.1.1
 Date: 6 June 2017 | Revision: E
 Plan prepared for Bay of Plenty Regional Council by Boffa Miskell Limited
 Project Manager: Kiana Milne@boffamiskell.co.nz | Drawn: Kih | Checked: Kiki

NIWA (2017i) established the most efficient and cost-effective methods for which to manage aquatic pest plants in Lake Rotorua for the next three years (sites identified in Figure 9.1.1). Unless stated otherwise, the proposed methods and associated diagrams/figures have been developed by NIWA.

Shoreline locations (Figure 9.1.1) ranked as high priority for pest plant management based on biosecurity concerns are Kawaha Point to Sulphur Point (Dragten Consulting 2016). Areas ranked as medium priority due to biosecurity include Ngongotaha, Hannahs Bay, Ohinemutu (as Utahina) and Hamurana (Figure 9.1.1), with Waingaehe ranked as medium priority due to amenity impacts (Dragten Consulting 2016).

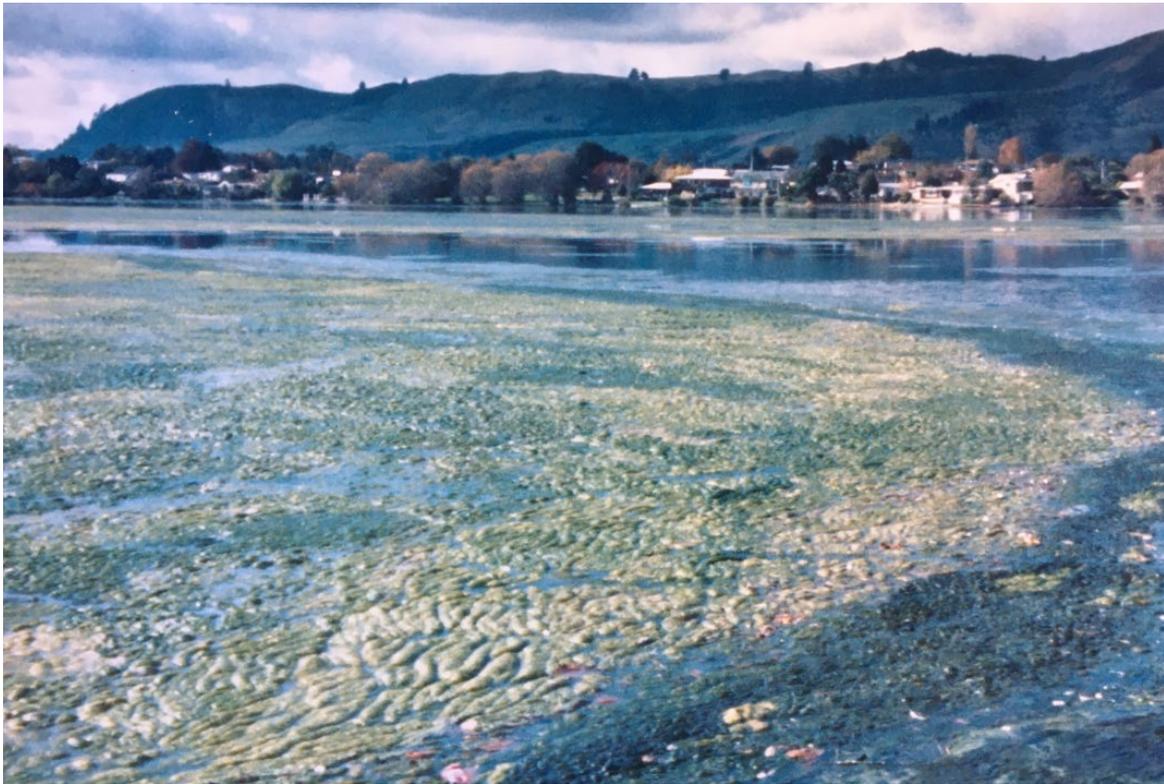
Figure 9.1.2 Lake Rotorua (late 1980's) with extensive weed beds of egeria covered in water net.

Lake Rotorua has the full range of problem invasive aquatic pest plants affecting the Rotorua Te Arawa lakes. An aquatic pest plant issue was first perceived by the public in the mid-1950's (Chapman 1970) following incursions and establishment of lagarosiphon. Egeria was first found in the lake in 1983 and is now the most abundant. It spread rapidly to form extensive surface reaching beds in 1988 (Figure 9.1.2) and has been the focus of control activities in the lake since. Hornwort is usually the most problematic pest plant in lakes, but it is scarce in Lake Rotorua, most likely due to the effects of a 10 km wind fetch on this poorly anchored plant. Elodea has been displaced by the more aggressive pest plants and is only found as a minor component of the vegetation, persisting in shallow water (<2.5m) where it is competitive in a short-growing form in this wave wash zone. Water net (*Hydrodictyon reticulatum*), a macroscopic green filamentous alga, was present in the lake at nuisance levels from 1988 to 1995 and very extensive growths caused major problems in the city foreshore area and at Ngongotaha (Figure 9.1.2).

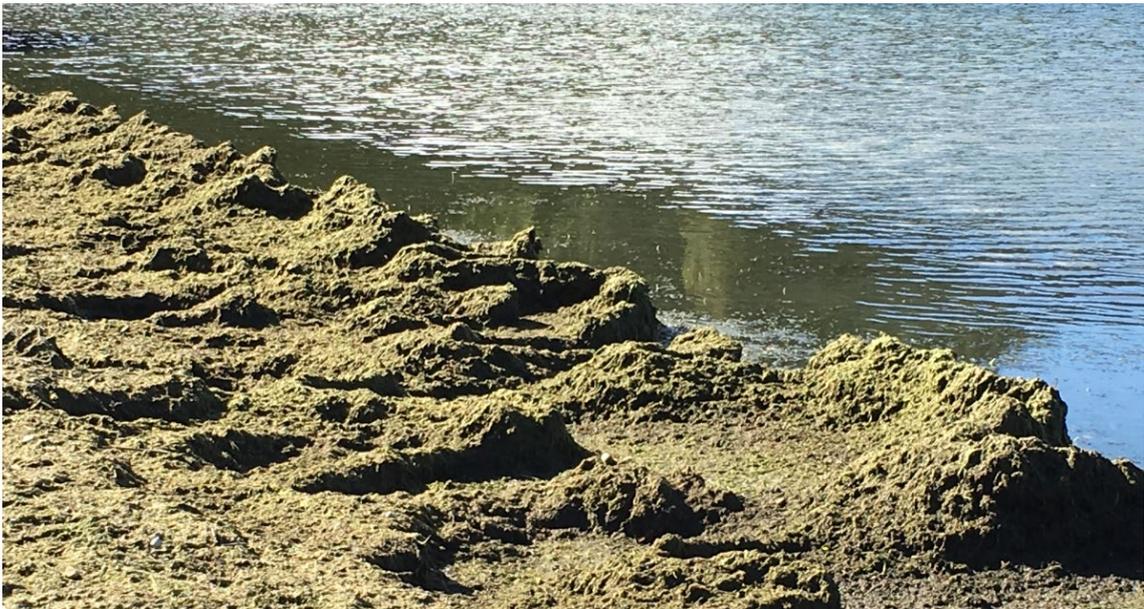
Figure 9.1.4 Aquatic weed stranding rotting on a sandy beach.

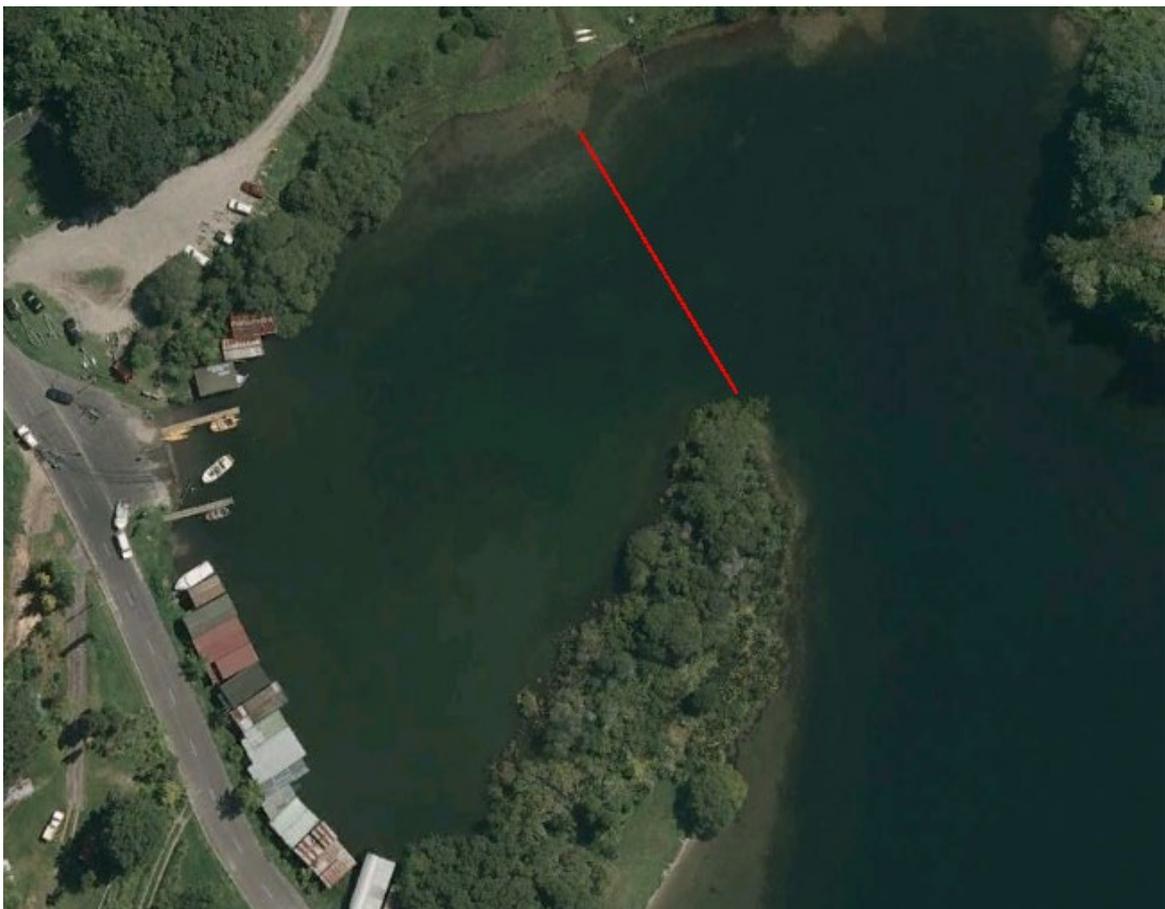
Figure 9.2.3 Lake Rotoiti Otaramarae boat ramp - area behind the red line proposed for bottom lining (Image sourced from: Google 2016).

It is recommended to bottom line the area behind (left of) the red line in Figure 9.2.3 (c. 60 m x 100 m); including the erection of a surface boom (red line) or weed cordon, with a drop net weighted at the bottom. Initial diquat treatment of the area would be required first to reduce biomass and facilitate bottom placement of lining material. There are a range of potential products suitable for bottom lining, including hessian and butanol rubber. However, product selection is dependent on siltation rates and likely maintenance requirements. Advantages of using hessian lining include reduced cost, as well as the potential for native charophyte plants to re-establish through the hessian lining, creating a deep-water carpet of native vegetation. If this proves successful then periodic (two to three years) diquat treatment will help ensure a long lasting native bottom-dwelling vegetation, while inhibiting the progressive invasion from tall invasive aquatic pest plant species.

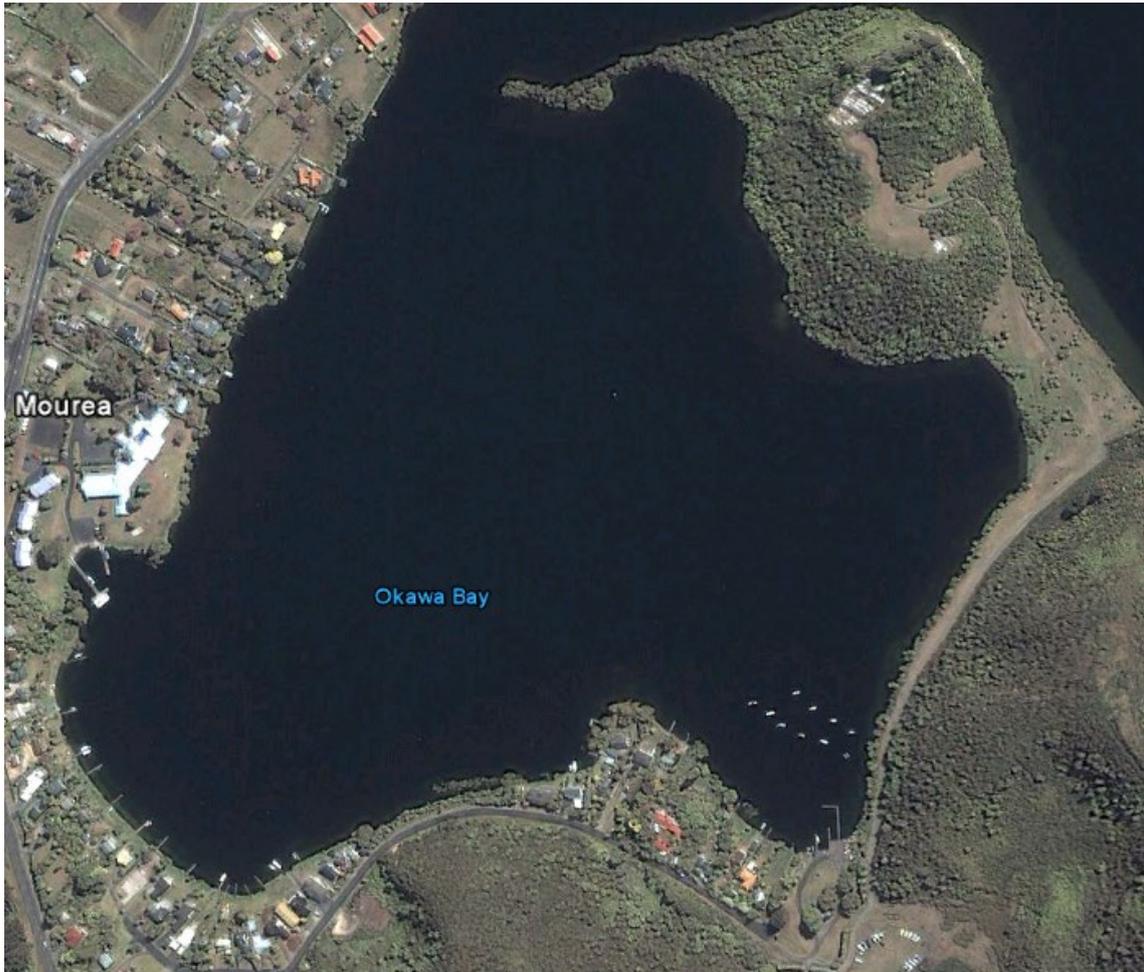
Figure 9.2.5 Okawa Bay – a sheltered semi-enclosed shallow bay that supports widespread submerged vegetation (Image sourced from: Google 2016).

Okawa Bay (Figure 9.2.5) is c. 1.8 km² with an average depth of c. 4-5 m. The area is largely covered in submerged vegetation, which requires periodic removal or control. The most common methods of control have been application of herbicide and cutting with a weed harvester. There has been debate over the choice and consequences of these two control methods, with suggestions that harvesting is best as this physically removes the pest plant and in doing so removes nutrients; as opposed to use of herbicide, which allows the plants to decay in situ with the potential for nutrient release and encouragement of algal blooms. The evidence is mostly inconclusive and both options have benefits and draw backs. The advantage of cutting the pest plant is that nutrient is removed from the bay. The process is slow and costly, with the same species re-growing faster than if they were sprayed. On the other hand, herbicide treatment is quick, cheaper than harvesting and offers the potential for native vegetation to recover from seed bank material in the sediment (which has been observed here and elsewhere on previous occasions).

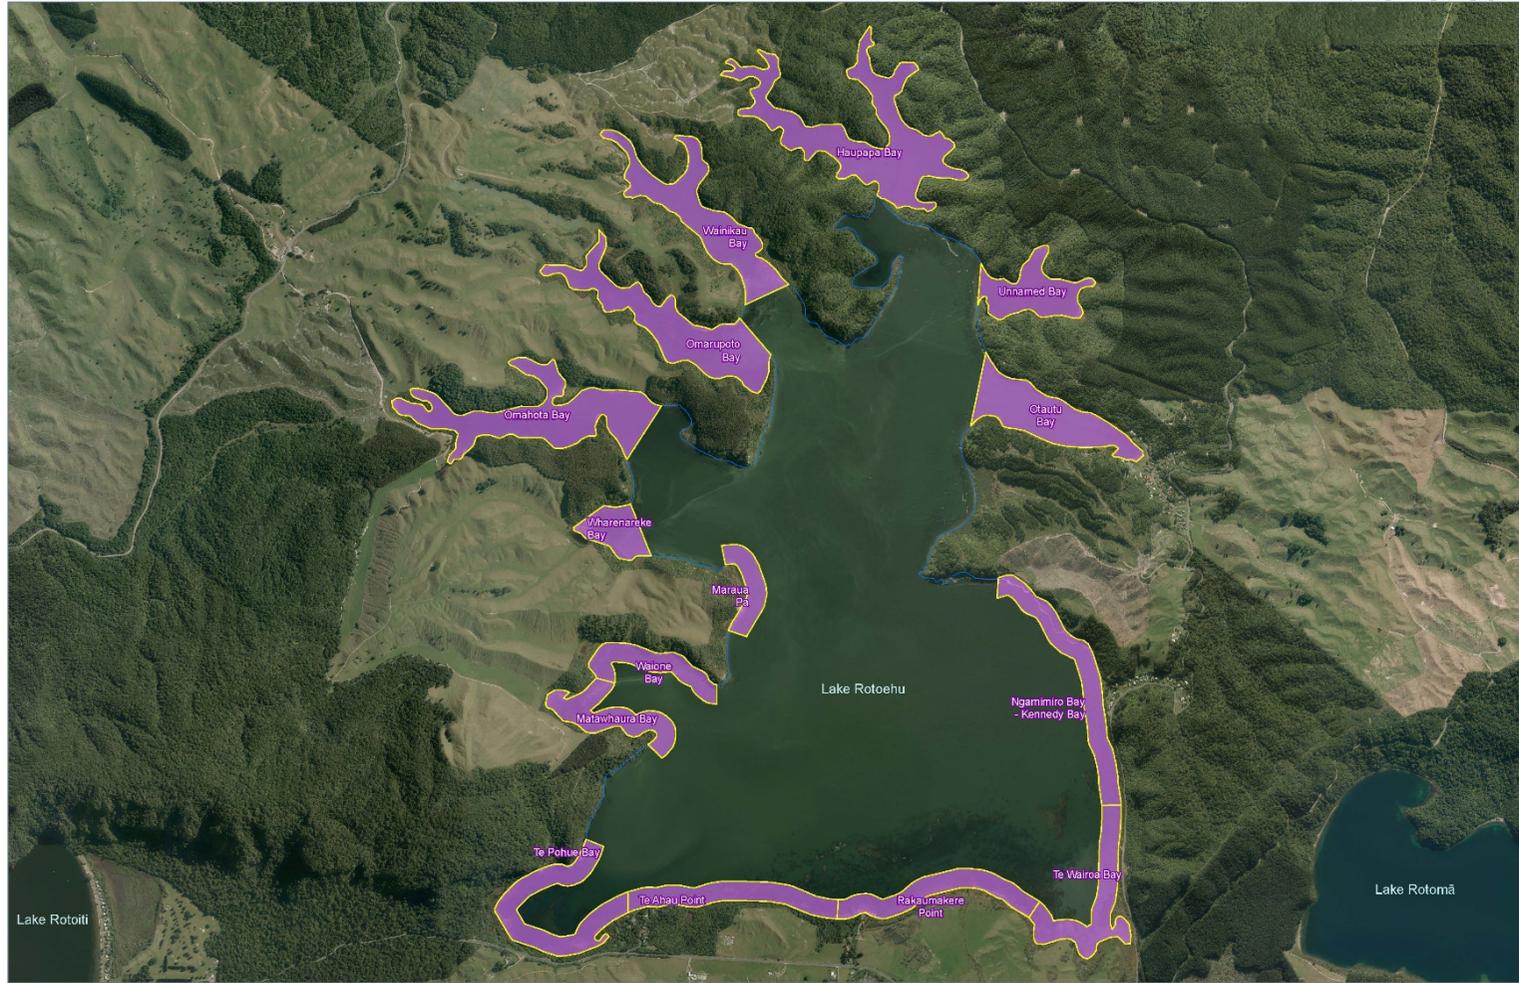
Site Extents - Lake Rotoehu - Figure 9.3.1

NIWA (2017e) established the most efficient and cost-effective methods for which to manage aquatic pest plants in Lake Rotoehu for the next three years (sites identified in Figure 9.3.1). Unless stated otherwise, the proposed methods and associated diagrams/ figures have been developed by NIWA.

Te Pöhue Bay (Figure 9.3.1) was ranked as medium priority for pest plant management due to amenity, while Ōtautū Bay and Kennedy Bay (see arrow at Ngāmimiro shoreline) were ranked as medium priority for biosecurity considerations (Dragten Consulting 2016). A considerable number of additional shoreline sites were identified for possible pest plant management (Figure 9.3.1) as all of those sites have high pest plant presence.

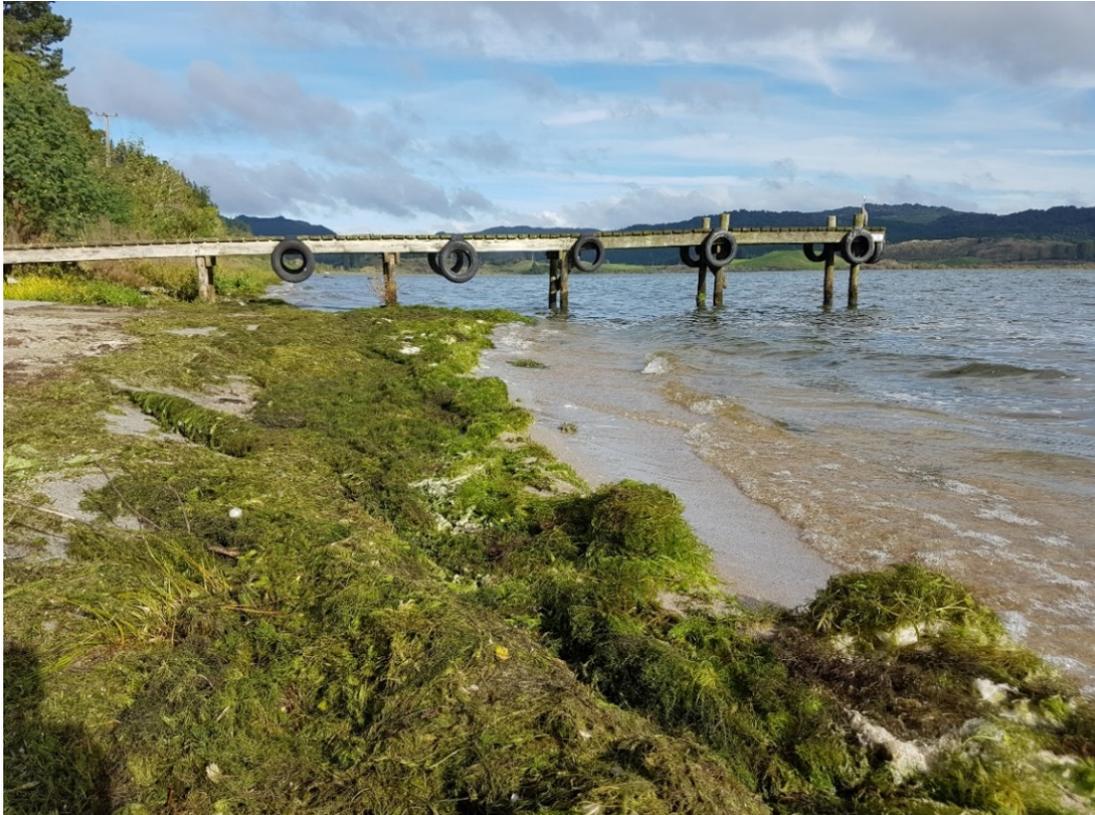
Figure 9.3.2 Drift hornwort accumulates in shallow bays and strands on the shoreline of Lake Rotoehu in 2016.

Pest plant control methods need to consider the goal statement for Lake Rotoehu to reduce hornwort in the northern arms, as well as control at biosecurity hot spots (boat ramps, jetties, popular beaches). Mechanical harvesting of drift accumulations of hornwort (Figure 9.3.2) has been carried out in Te Wairoa Bay for many years, not for amenity or biosecurity management but for nutrient remediation. Pest plant management recommendations are cognisant of and are not expected to compromise the continuation of weed harvesting initiative at the Te Wairoa site.

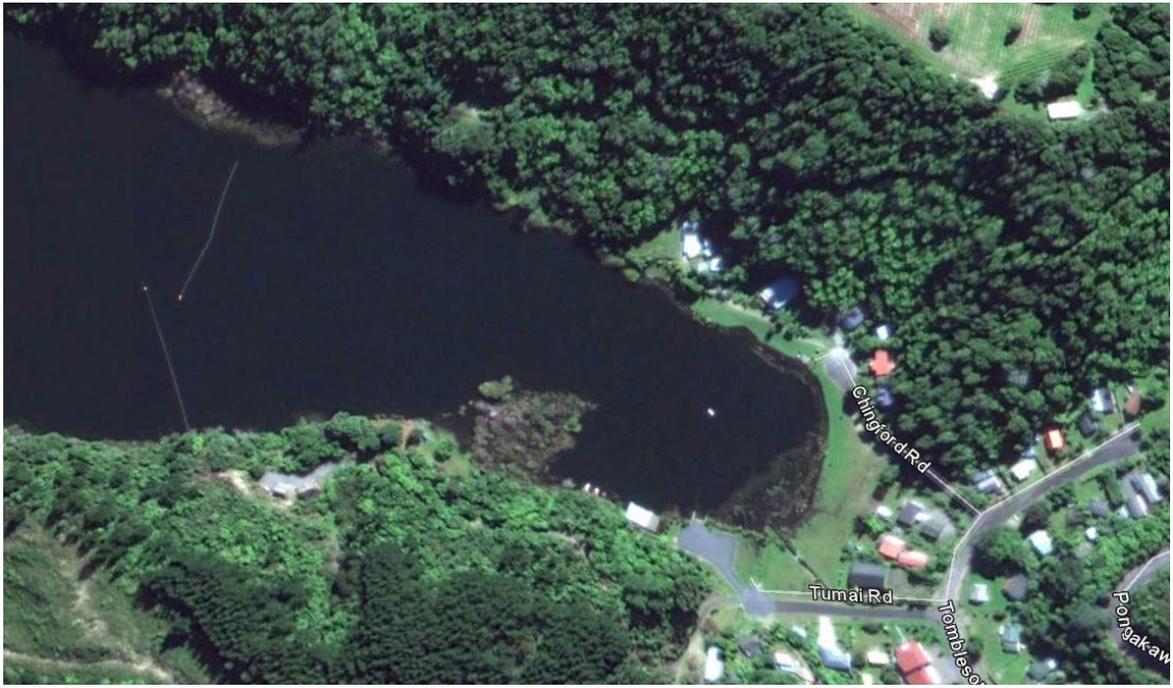
Figure 9.3.3 Ōtautū Bay showing the configuration of the weed cordon (Image sourced from: Google 2016).

Pest plant management at these sites should be focused on biosecurity and amenity near access points and infrastructure. Both the sites have a boat ramp and adjacent jetty. Ōtautū Bay is a deep, sheltered arm and has a weed cordon located c. 300 m from the ramp at the head of the bay (Figure 9.3.3). Kennedy Bay ramp is located at an open lake site.

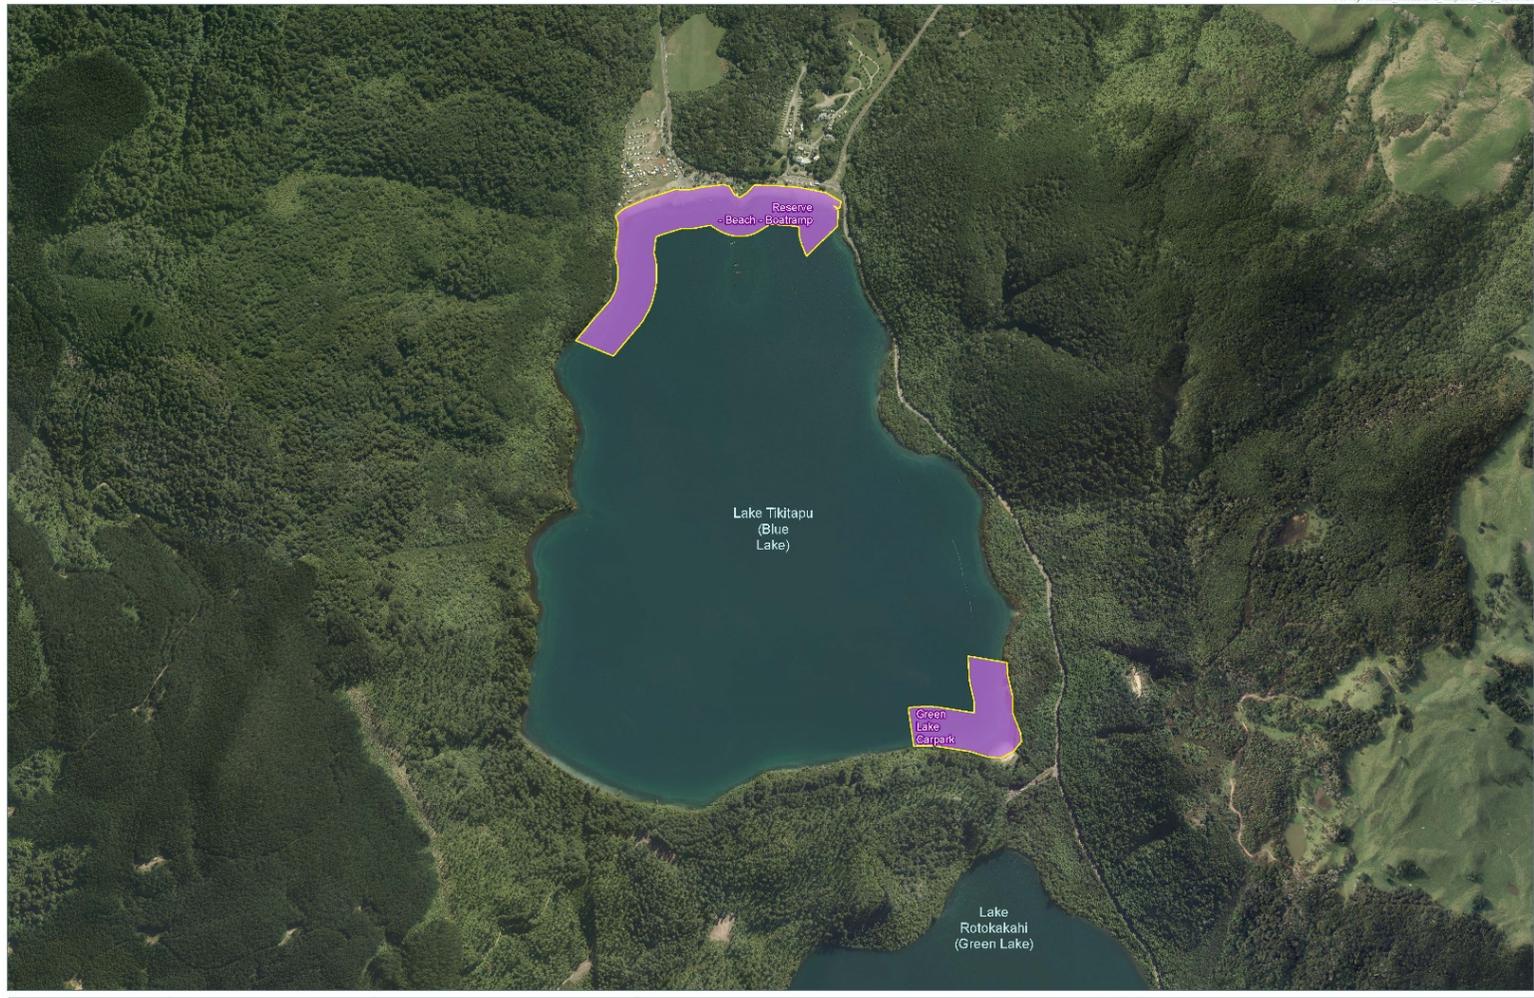
Figure 9.7.1.

ROTORUA LAKES MANAGEMENT PLAN
 Site Extents - Lake Tikitapu (Blue Lake) - Figure 9.7.1
 Date: 6 June 2017 | Revision: E
 Plan prepared for Bay of Plenty Regional Council by Boffa Miskell Limited
 Project Manager: Kieran.Miller@boffamiskell.co.nz | Drawn: ATH | Checked: KMI

Two shoreline sites are proposed for pest plant control consideration in Lake Tikitapu. The first site is the combined boat ramp and swimming beach at the north of the Lake (Figure 9.7.1). This site was ranked as medium priority for biosecurity reasons (Dragten Consulting 2016). The second site is the 'Green Lake' carpark, which was ranked as medium priority for amenity reasons (Dragten Consulting 2016).

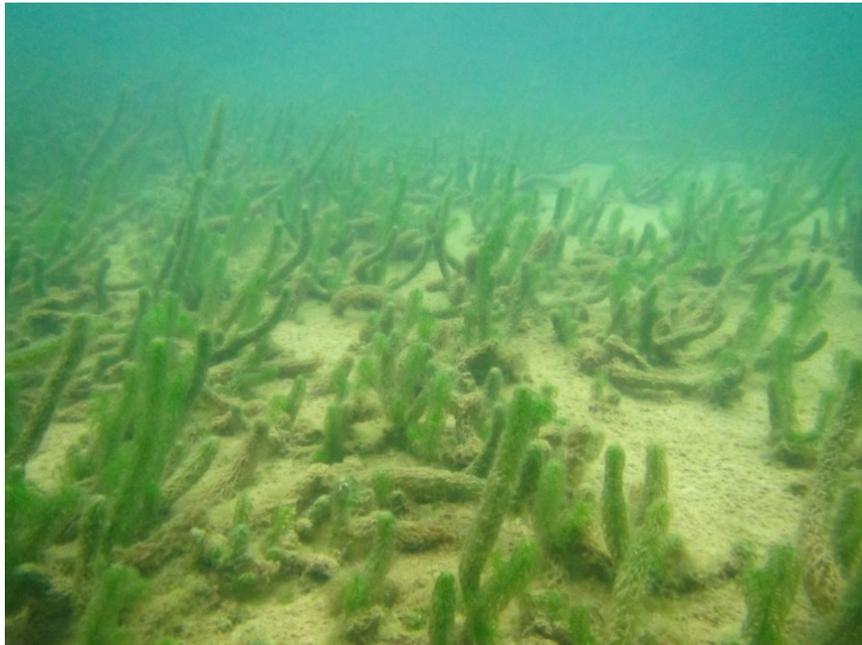
Figure 9.7.2 Typical lagarosiphon growth form in Lake Tikitapu.

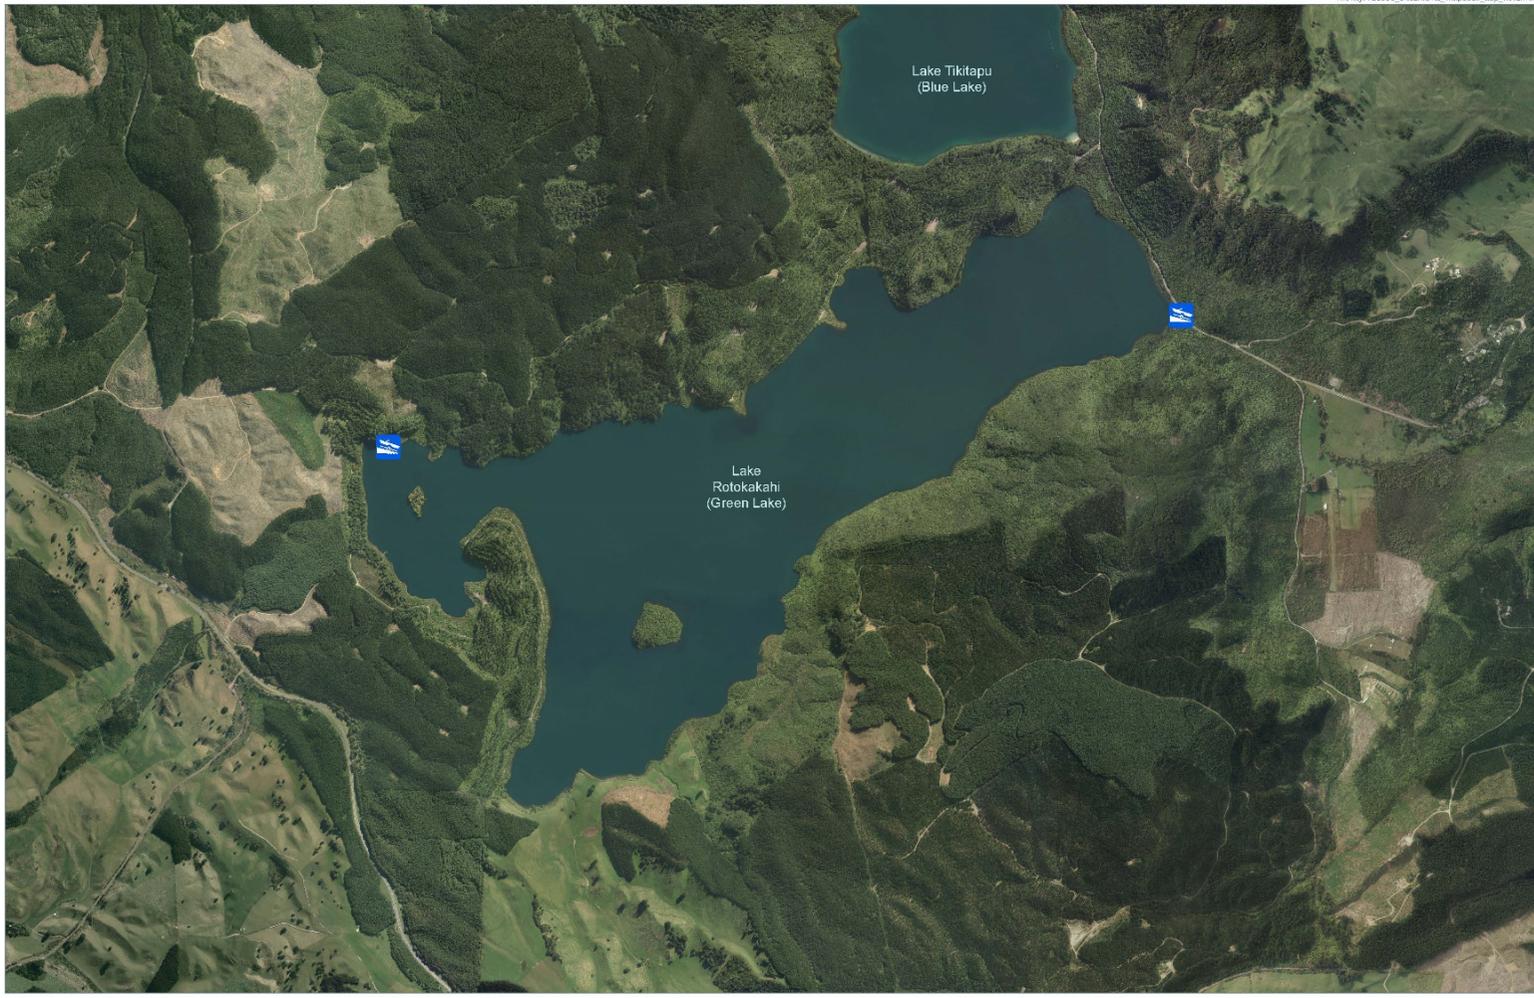
Figure 9.8.1.

ROTORUA LAKES MANAGEMENT PLAN
 Site Extents - Lake Rotokakahi (Green Lake) - Figure 9.8.1
 Date: 6 June 2017 | Revision: E
 Plan prepared for Bay of Plenty Regional Council by Boffa Miskell Limited
 Project Manager: Kieran Miller@boffamiskell.co.nz | Drawn: ATH | Checked: KMH

The whole shoreline of Lake Rotokakahi (Figure 9.8.1) was ranked as medium priority for pest plant management due to biosecurity considerations (Dragten Consulting 2016). Elodea is the only invasive aquatic plant species confirmed within the lake and currently dominates the vegetation (Clayton *et al.* 1990, Burton 2016). However, elodea is of lesser concern compared to other more invasive aquatic pest plants (Clayton *et al.* 1990). Invasion by lagarosiphon, egeria or hornwort would create greater impacts for users.

Lake Rotokakahi is privately owned by mana whenua and is predominantly used by tribal members for recreational fishing. Two beach launch sites are most commonly used (Figure 9.8.1). Elodea does not impact on amenity at either site, although there is a risk of its transfer from the lake on trailers, boats or fishing equipment.

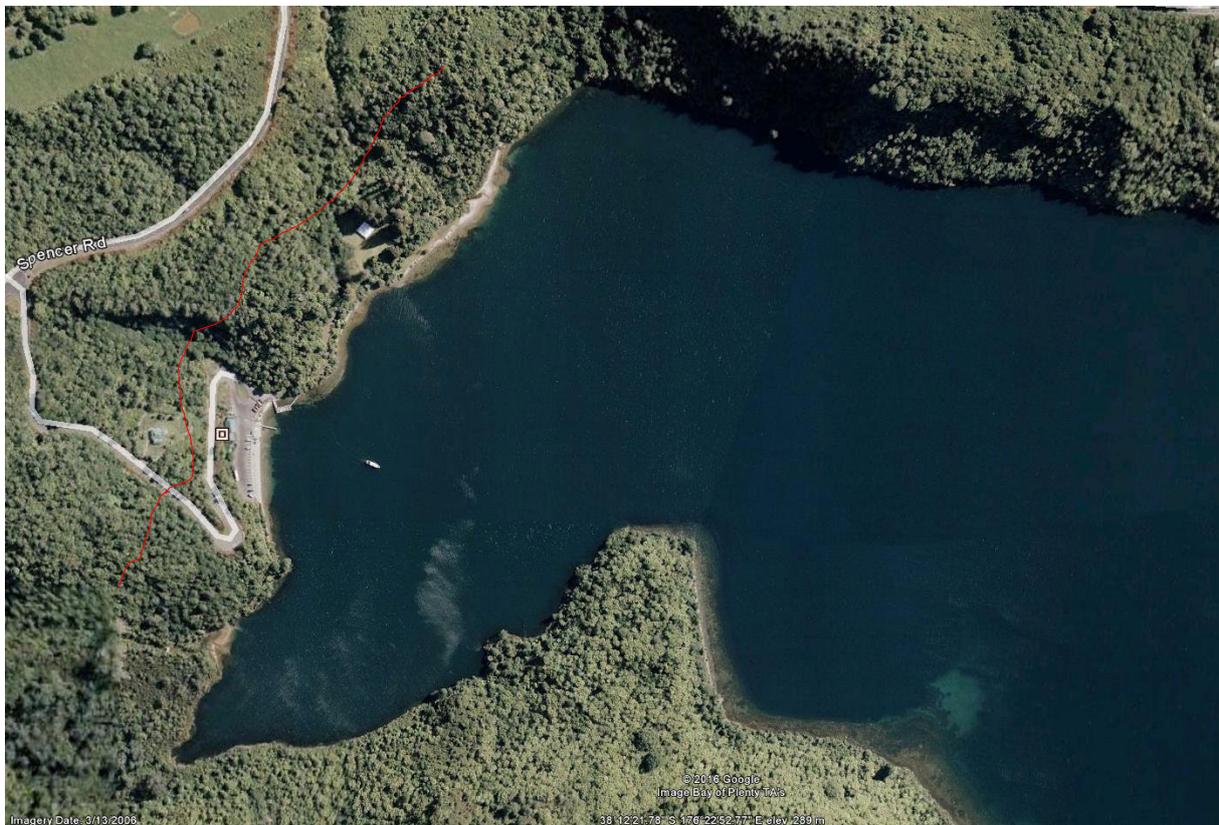
Figure 9.9.3 Tarawera landing and the proposed priority pest plant control treatment area (red line) for amenity and biosecurity (Image sourced from: Google 2016 and Bay of Plenty TA's).

Annual treatment at this location with the herbicide diquat is recommended (Figure 9.9.2, Table 9.9.3), with spraying the shoreline extending approximately 400 m north and 200 m south to limit re-invasion (Figure 9.9.3).

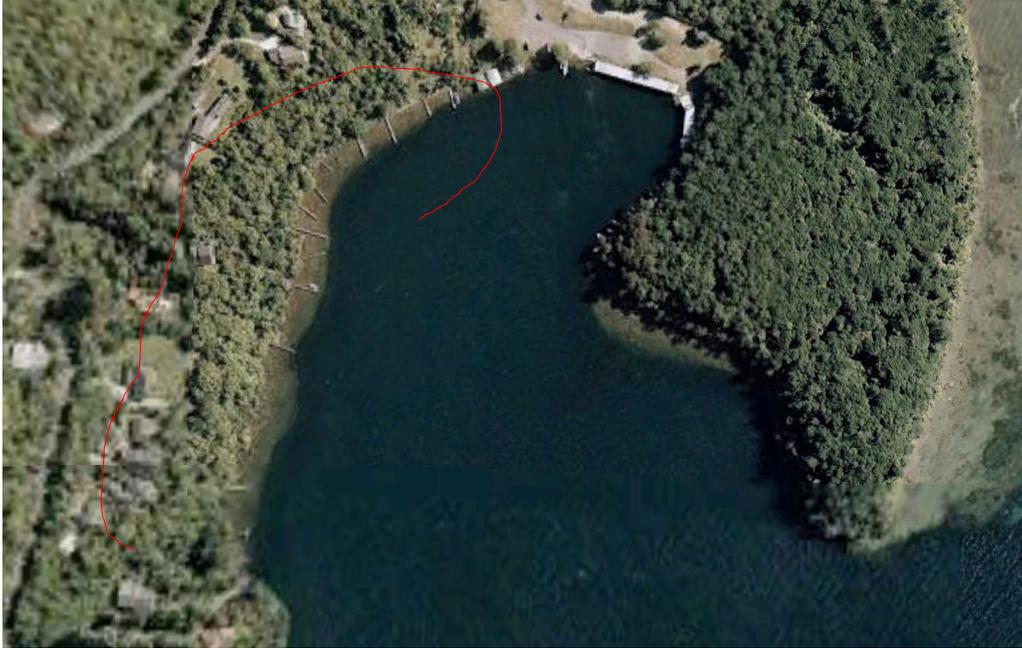
Figure 9.9.4 Boatshed Bay and the proposed priority pest plant control treatment area (red line) for amenity and biosecurity (Image sourced from: Google 2016 and Bay of Plenty TA's).

Spraying with diquat around the perimeter of the inner bay (Figure 9.9.4) on an annual basis (Figure 9.9.2, Table 9.9.3) is recommended to prevent hornwort drift from encroaching in front of the ramps, boatsheds and jetties.

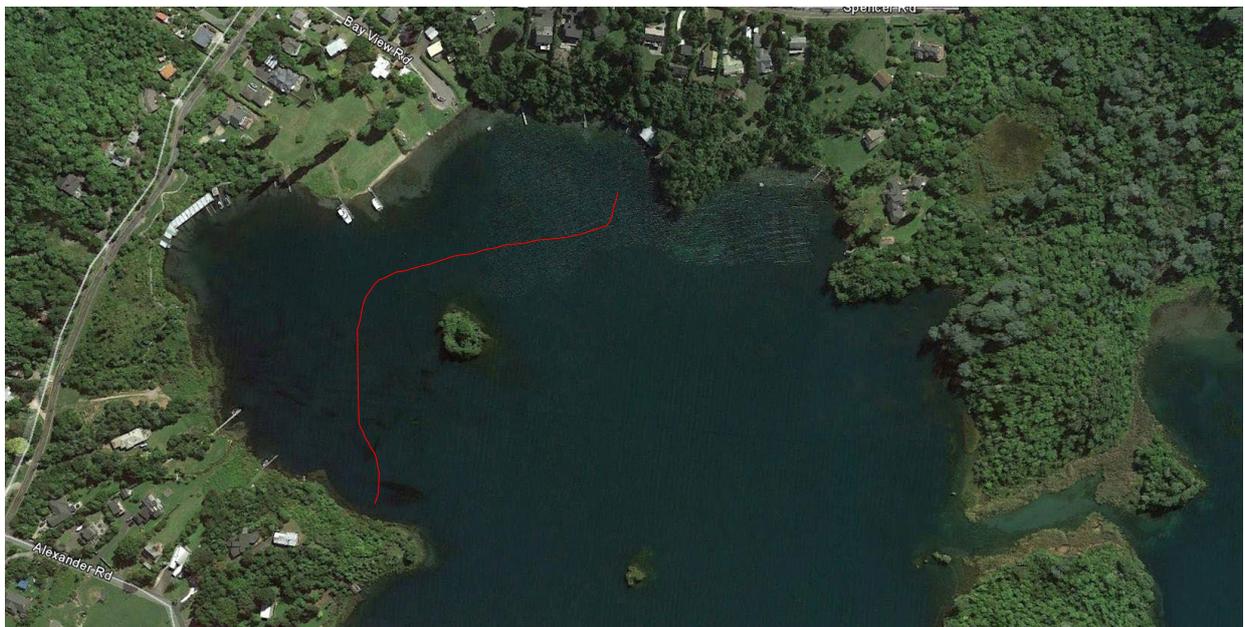
Figure 9.9.7 Otumutu Lagoon with the area of seasonal hornwort enclosed within the red line (Image sourced from: Google 2016).

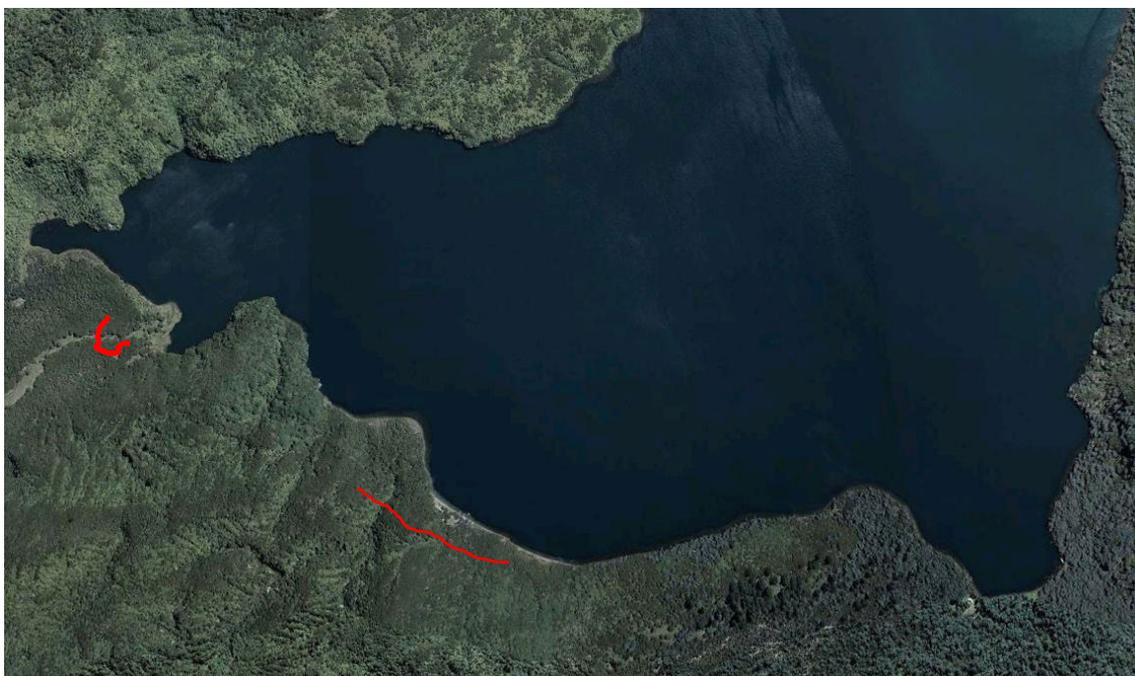
Figure 9.9.8 Hot Water Beach and the entrance to popular natural hot pools, showing the recommended extent of diquat treatment (Image sourced from: Google 2016 and Bay of Plenty TA's).

Annual diquat treatment is recommended (Figure 9.9.2, Table 9.9.3) for the sites as marked in Figure 9.9.8.

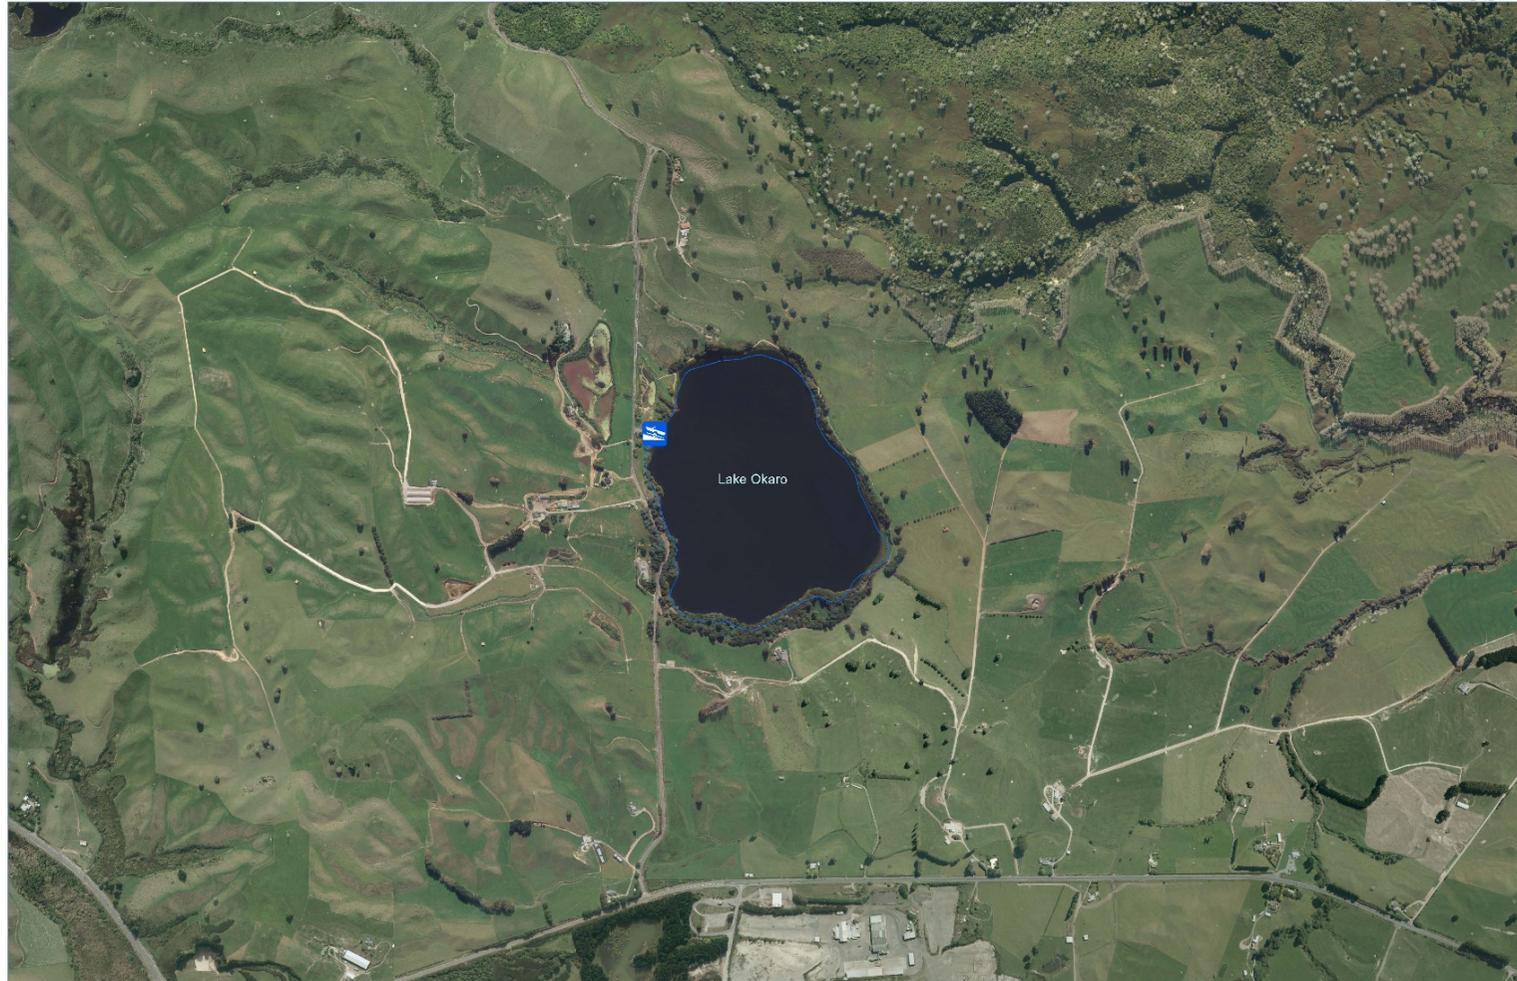
ROTORUA LAKES MANAGEMENT PLAN
Site Extents - Lake Okaro - Figure 9.11.1

The whole shoreline of Lake Okaro (Figure 9.11.1) was ranked as medium priority for pest plant management due to biosecurity considerations (Dragten Consulting 2016). Elodea and curly pondweed are the only invasive aquatic pest plant species to be recorded in this lake (Clayton *et al.* 1990, Burton 2016), both of which although widespread, are considered to be at the less invasive end of the spectrum compared with lagarosiphon, hornwort and egeria. Impacts are likely to worsen considerably in the event of those aquatic pest plants establishing in Lake Okaro, so preventative biosecurity is a key focus for this lake.

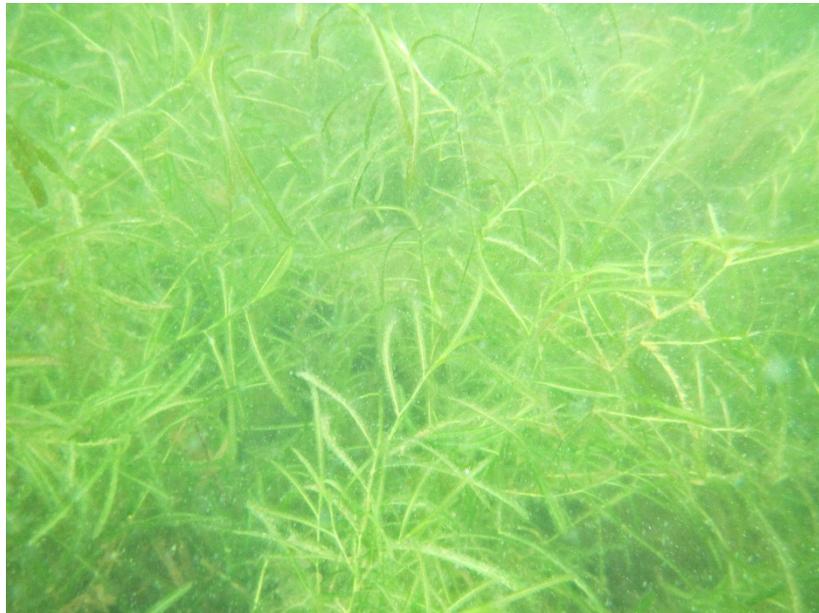
Figure 9.11.2 Native pondweed dominated Lake Okaro in March 2017 following a decline in elodea.

In the past, submerged vegetation was almost solely comprised of elodea in Lake Okaro. Elodea fluctuated in cover and depth range, apparently in response to fluctuating water quality and clarity in this degraded lake (Burton 2016). Considerable initiatives have been applied to the lake and catchment to improve water quality in recent years. Most recently (early to mid-2017) a large reduction in the dominance of elodea has been observed (NIWA unpublished data) and an increase in native pondweeds (especially *Potamogeton ochreatus*) has occurred (Figure 9.11.2). This reflects the tendency for elodea to be an early coloniser following disturbance compared to other pest plants. Elodea is an early coloniser following disturbance, but can be outcompeted by other (including native) plants under more stable lake conditions.

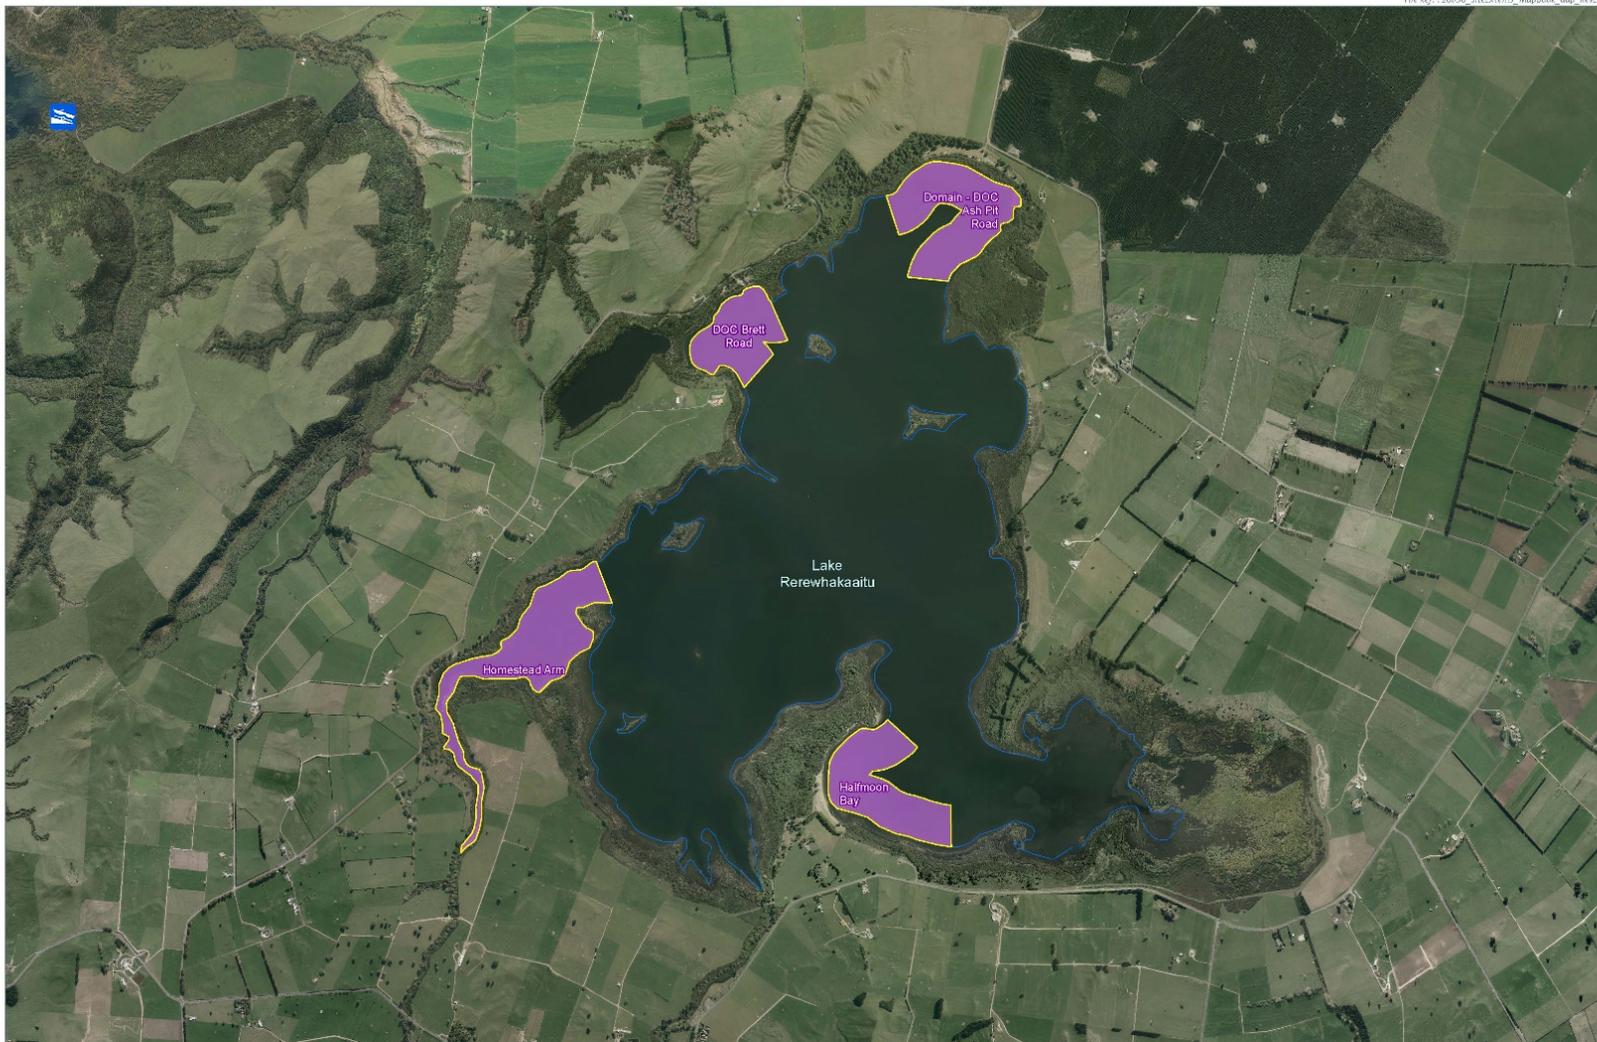
103 Figure 9.12.1

ROTORUA LAKES MANAGEMENT PLAN
 Site Extents - Lake Rerewhakaaitu - Figure 9.12.1
 Date: 6 June 2017 | Revision: E
 Plan prepared for Bay of Plenty Regional Council by Boffa Miskell Limited
 Project Manager: Kieran.Miller@boffamiskell.co.nz | Drawn: Ath | Checked: KMI

Site priorities for pest plant management have been ranked as medium based on biosecurity for Homestead Arm and Domain/DOC Ash Pit Road (Dragten Consulting 2016). Department of Conservation Brett Road was ranked as low priority (Dragten Consulting 2016). Also, the informal boat launch area at Half Moon Bay (Figure 9.12.1) is of potential biosecurity concern.
