Rotorua Te Arawa Lakes Aquatic Plant Management Plan

Prepared for Bay of Plenty Regional Council & Land Information New Zealand

8 May 2020

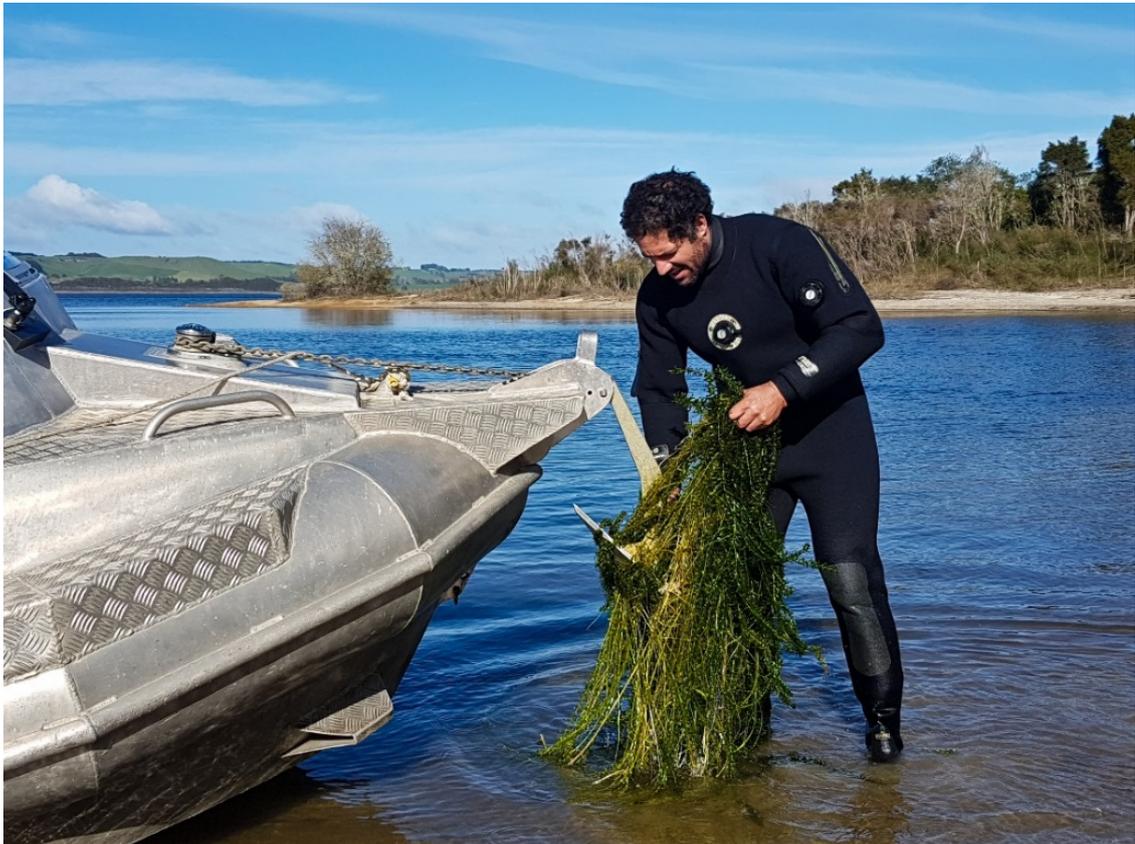
Figure 9.12.3 *Egeria* and *lagarosiphon* is cleared from an anchor used in Lake Rerewhakaaitu.

This site is a popular recreational beach with two or more informal launch places. The width of the shallow sandy beach limits boat and trailer contact with the weed beds during launching and retrieval. However, weed beds pose potential for amenity impacts further offshore and there is biosecurity risk from equipment fouling albeit lower than Homestead Arm (Figure 9.12.3).
